Structural Health Monitoring of a Bonded Composite Patch Repair on a Fatigue-Cracked F-111C Wing

DSTO-RR-0335

A large fatigue crack in the wing skin of an Australian Defence Force F-111C aircraft was repaired with an adhesively bonded boron/epoxy fibre composite patch. The patch prevented further growth of the crack for 670 flying hours.

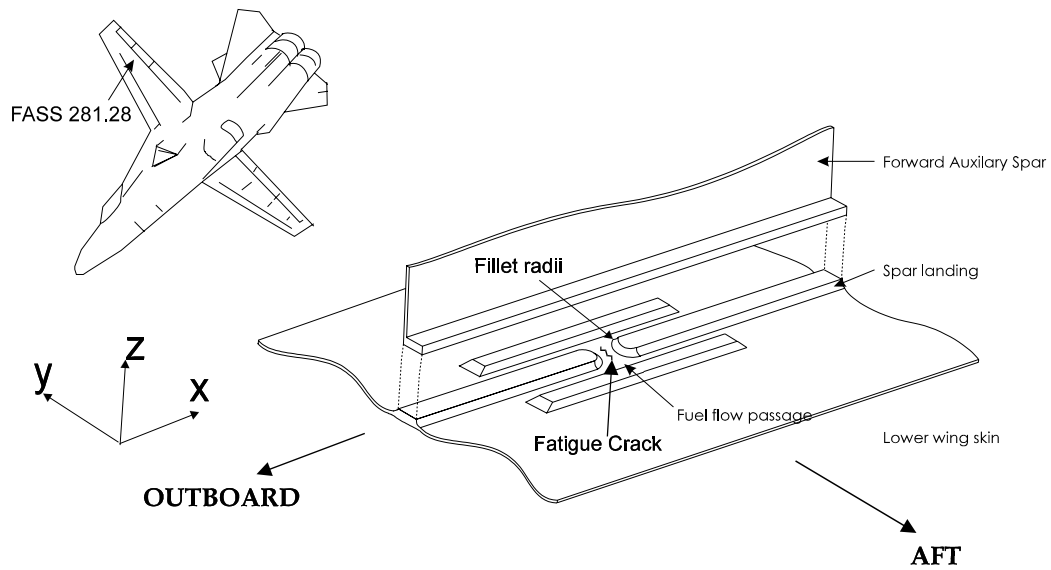
The fatigue crack was discovered in the region of the Forward Auxiliary Spar Station (FASS) 281 in the lower wing skin A15-5 of aircraft A8-145 during a routine visual inspection. The wing skin material is aluminium alloy 2025-T851, ~ 4 mm thick in the region of concern.

The first visual indication of the crack was fuel seepage around the crack site. A more detailed follow-up NDI inspection of this region revealed a through-thickness crack, 48 mm long tip-to-tip.

Figure 1 indicates the location of cracking on the lower wing-skin. The cracking occurred in an area lying below the forward auxiliary spar at FASS 281.28, where the thickness of the integral stiffener is reduced from approximately 8 mm to the nominal skin thickness (at this location) of approximately 4 mm. The purpose of this depression in the stiffener is to allow full fuel flow and drainage between adjacent bays of the wing-box fuel tank. Two side-stiffeners are intended to compensate for the loss of spanwise stiffness due to this fuel-flow passage, as indicated in Figure 2. These geometrical features lead to a significant stress concentration factor and to out-of-plane or secondary bending at the location of cracking, as discussed in Reference [5].

Figure 1 Location of cracking on the F-111 lower wing-skin, at FASS 281

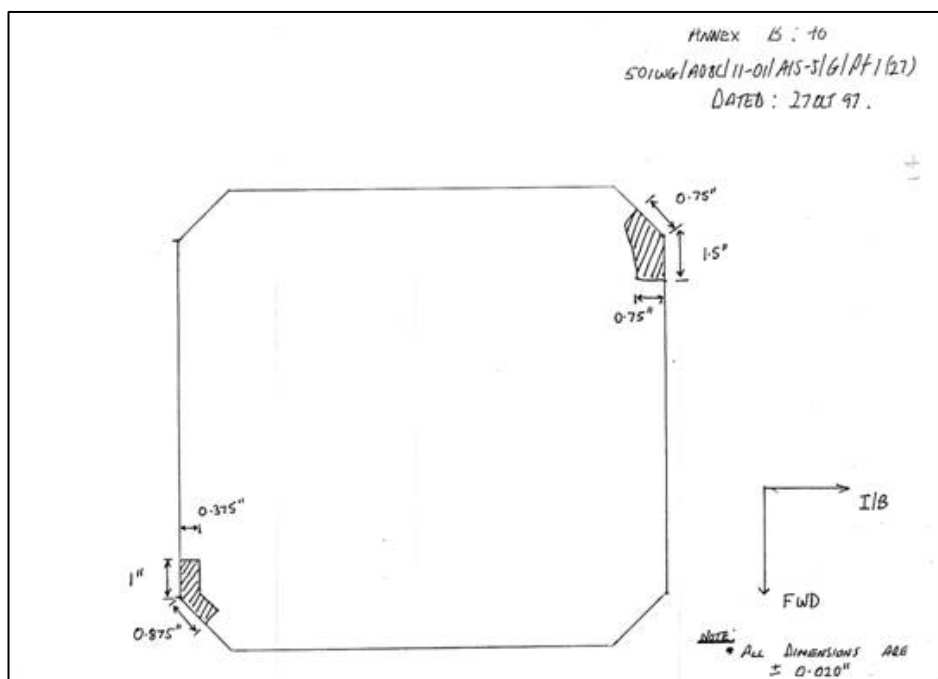
The disbond history of the patch during service was somewhat more difficult to interpret. There is a report of the presence of disbands in the patch system after application at 4749.5 flying hours; however, the disbands reported were very small (less than 3mm diameter) and generally not in the regions where the disbands were detected later. No further disbands were found until at 5417.7 flying hours when clearer and more credible indications of disbands were obtained, as indicated in Figure 8, which shows relatively small disbands at the patch corners.

Figure 8 Sketch of disbands detected by RAAF inspection at 5607 hours, just prior to retiring of wing for the fatigue test

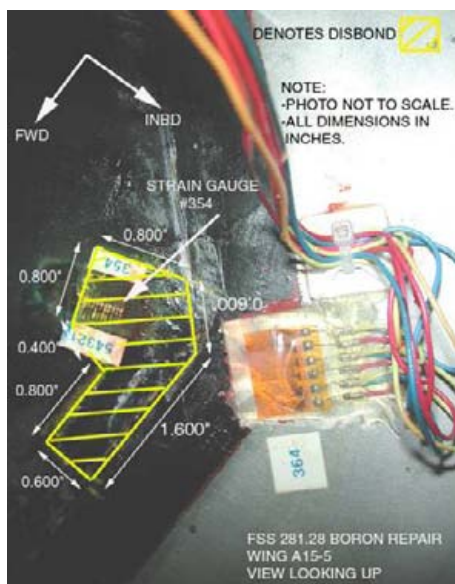
Figure 13: NDI indications of disbonds at 10572 SFH ~ Block 10 in the region of skin gauge 364 and patch gauge 354. Later at Block 12 strip gauges 356 and 357 and single gauge 803 were

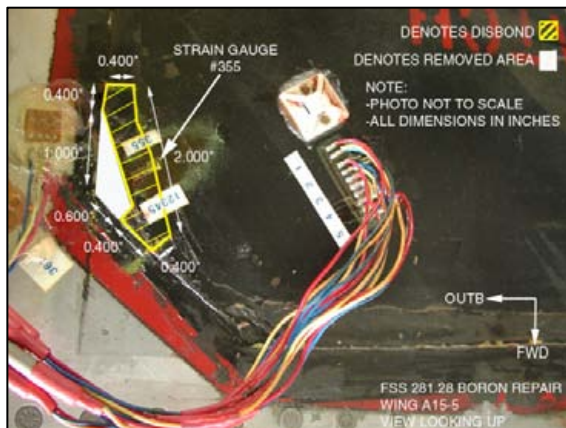
Figure 15: NDI indications of disbonds between the patch and substrate material at 10572 SFH Block 10 in the region of skin gauge 361 and patch gauge 355. Later, at Block 12 patch strip gauges 358 and 359 were applied in this region

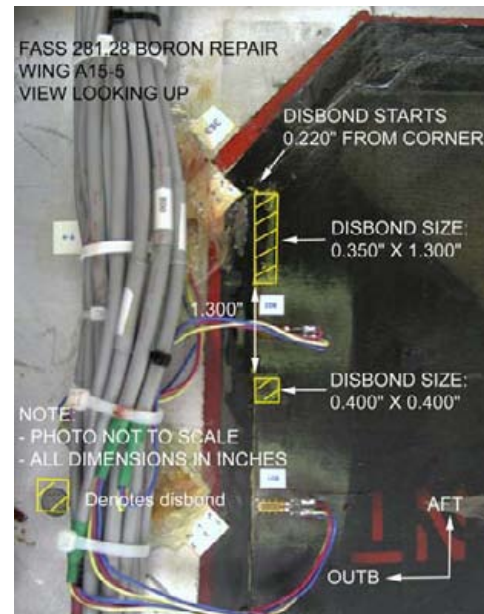
Figure 16: NDI indications of disbonds between the patch and substrate material at 11082 SFH ~ Block 11 in the region of skin gauges 363 and 361. Later at Block 12 patch gauges 802, 800 and 805a were bonded to this region

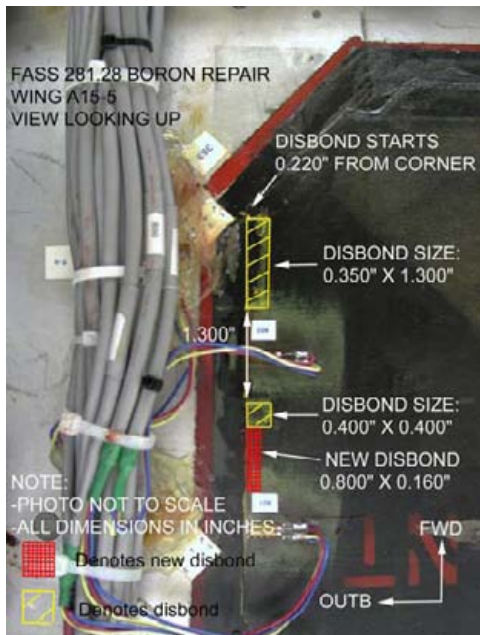
Figure 17: NDI indications of disbonds between the patch and substrate material at 11500 SFH Block 12 in the region skin gauges 363 and 361. Later patch gauges 802, 800 and 805a were bonded to this region.

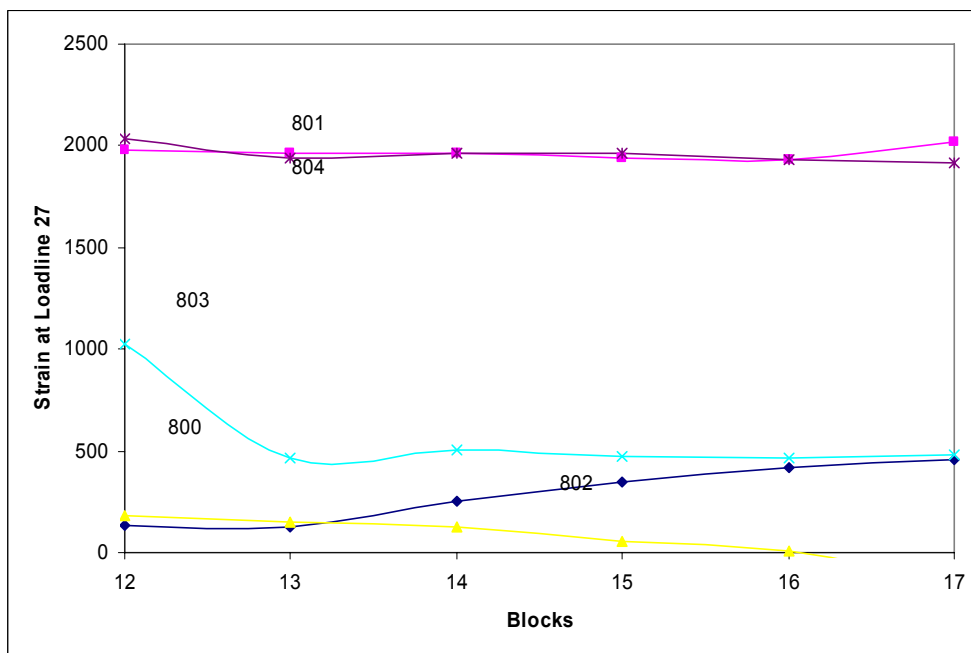
- Gauge 804 is located in a region where no damage was detected by NDI so the high readings obtained are expected.
- Single gauge 800, 802, Figure 32
- These gauges clearly indicate pre-existing damage, in accord with the NDI disbond indications for these regions, as shown in Figure 14.
- Gauge 803 indicates some damage growth, in accord with the NDI readings for this region as shown in Figure 13.

Figure 32: Strain versus blocks for single gauges for Blocks 12 to 17

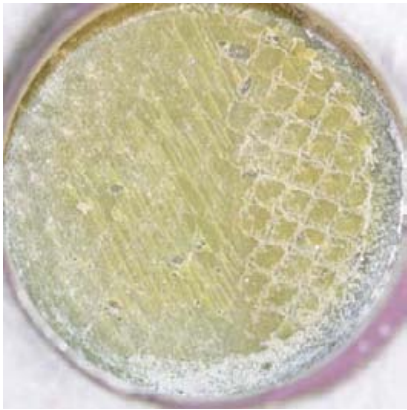
Figure 35 Photographs of fracture surfaces produced by the bond test, showing the main failure modes, as indicated
